The Art of Diagnosing a un-Healthy Water Bore and Rehabilitation techniques

Greg Brereton

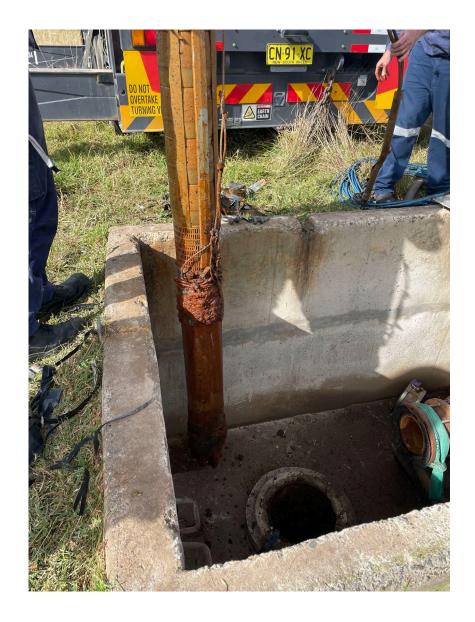
Iron Bacteria Biofouling on Bore Pump

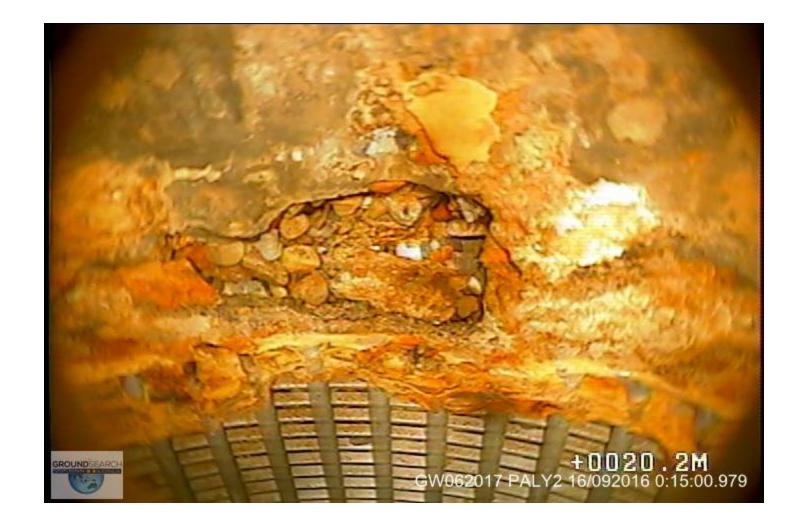
Source : M Glofelty The Art of Water Wells Water Resources Drilling Corrosion due to dis-similar metals mild steel casing and stainless Steel Screen

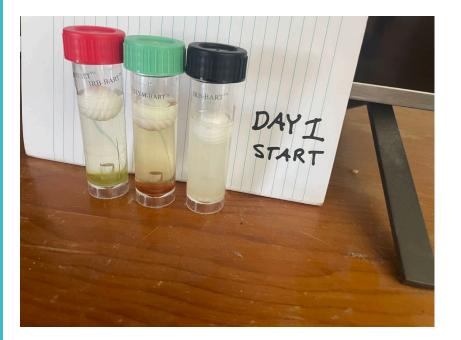
#### DAY 1

### BART COMPARISON

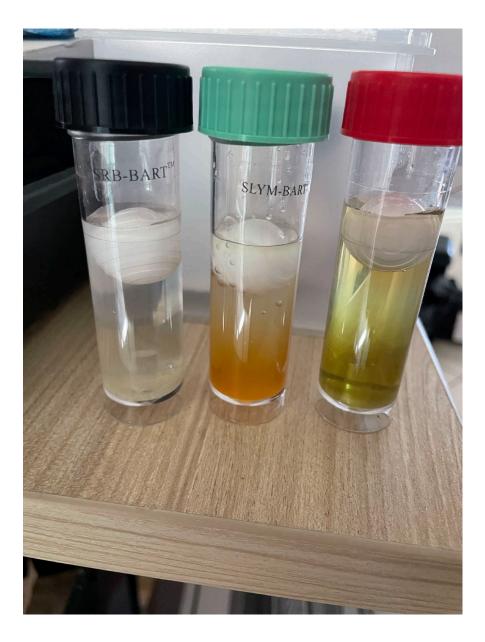
BART Nabiac Town Water, bore Dayriling

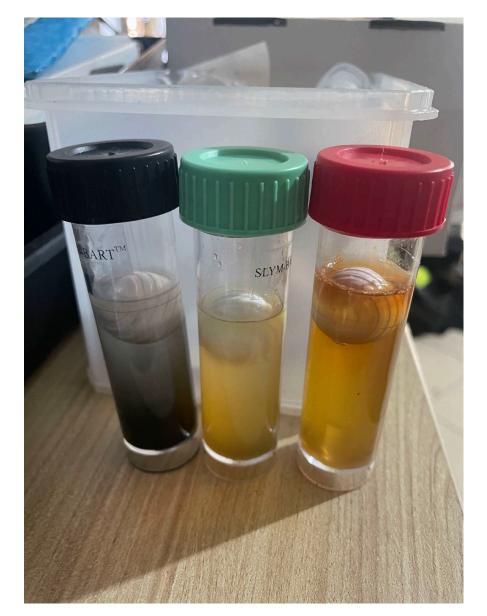
BART Nabiac Town Water bore Day 8

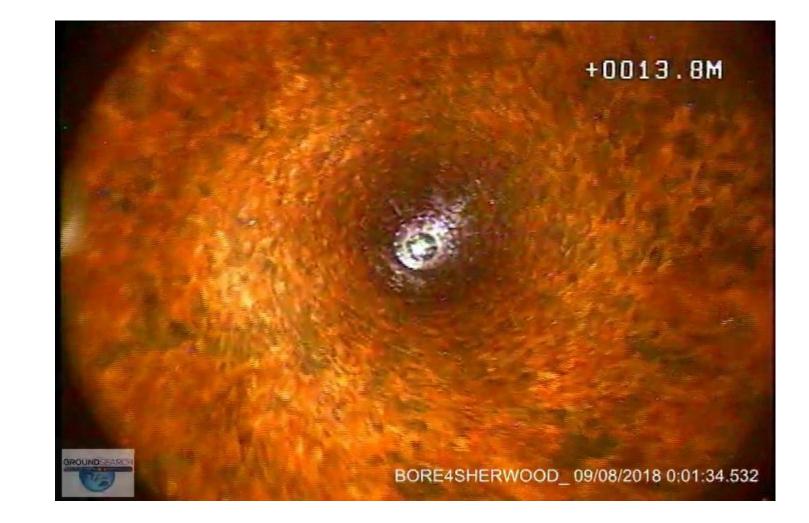
### Rusted Casing above Water table

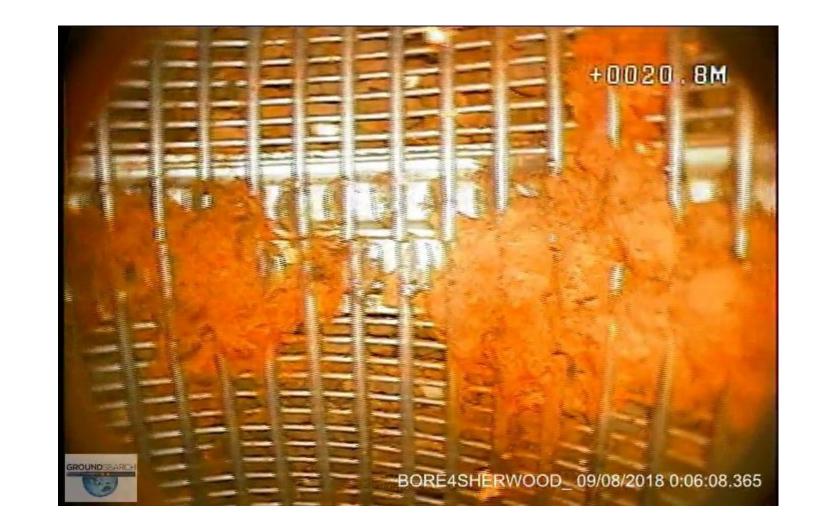
Iron Bacteria Early Stages Video Camera inspection

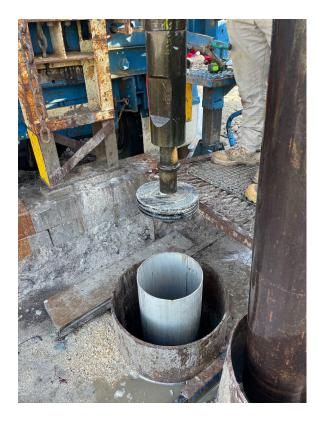
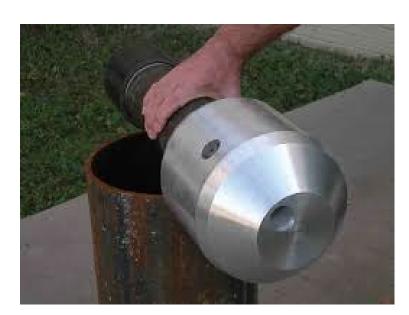
#### **Jetting Tool**

Surge Tool and Bailer

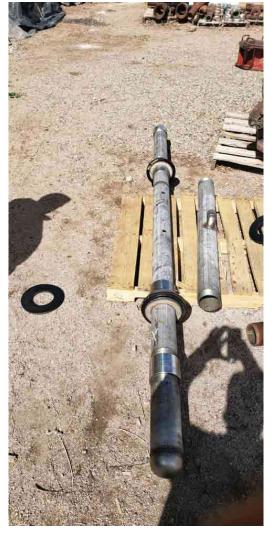
Combined Surge and Air Eductor tool

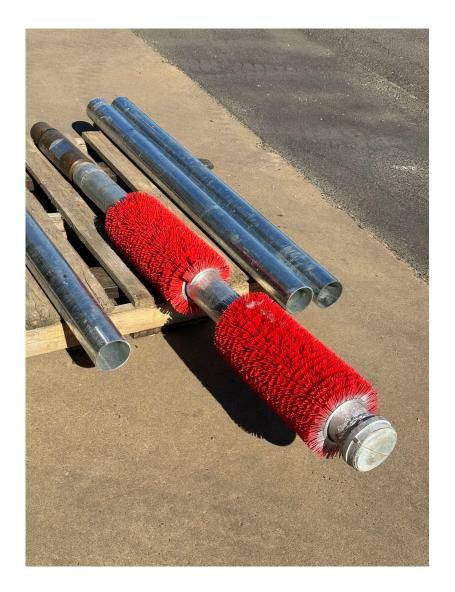
### Casing and Screen Brush
